REPORT NATF-EN-1132

BAK-14 RETRACTABLE HOOK-CABLE SUPPORT SYSTEM
COLD-WEATHER TESTS AT GALENA, ALASKA

Waldemar Wastallo
Recovery Division, Engineering Department
Naval Air Test Facility
Naval Air Station
Lakehurst, New Jersey 08733

27 AUGUST 1974

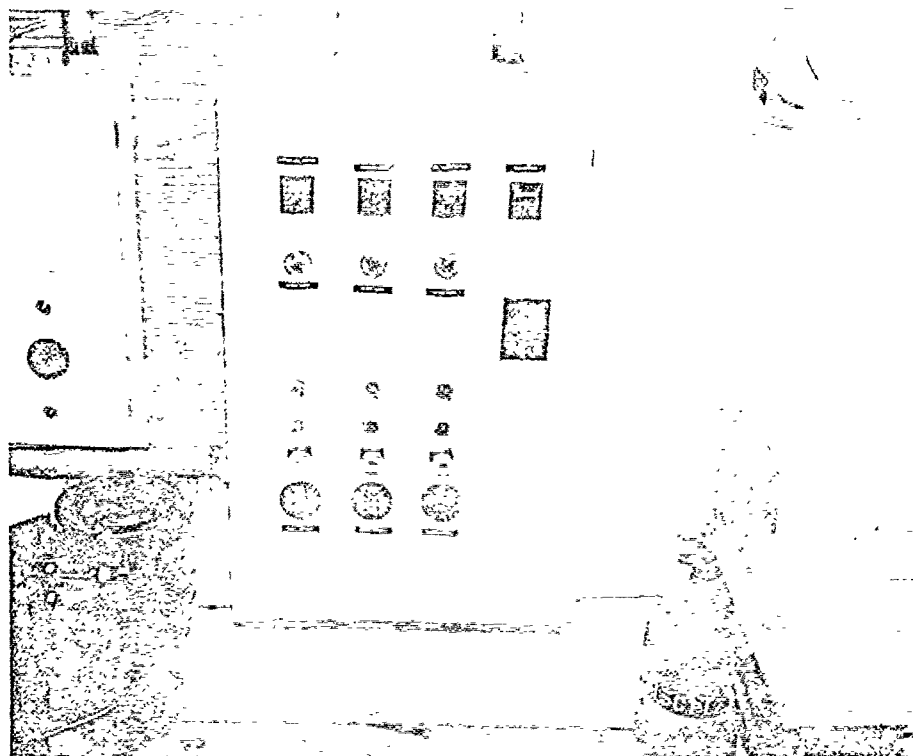
FIGURE 5 - HEATER CONTROL BOX (CENTER) AND THE SUPPORT ARM LIMIT SWITCH CHECK CIRCUIT CONTROL BOX (LEFT)

g. Verification of the electrical continuity of the support-box, trough, and end-trough heaters was attempted by operating the check circuit provided on the heater control panel in the BAK-12 pan. The heater control box is shown in Figure 5 on page 10. The verification was unsatisfactory for the following reasons:
